Situation Photo Log

Thursday, July 19, 2012 Kalamazoo River / Enbridge Spill

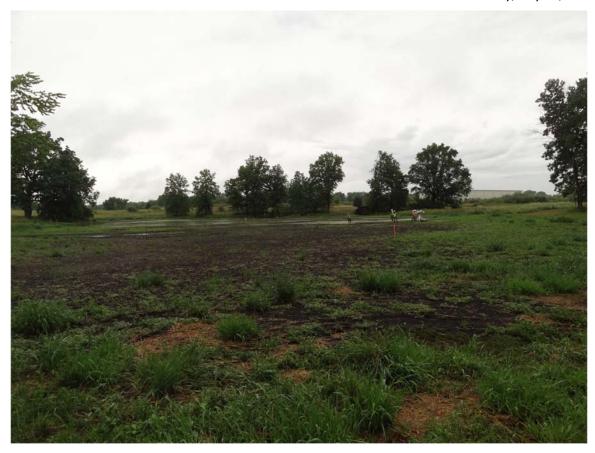
1. Source Area soil core sampling.

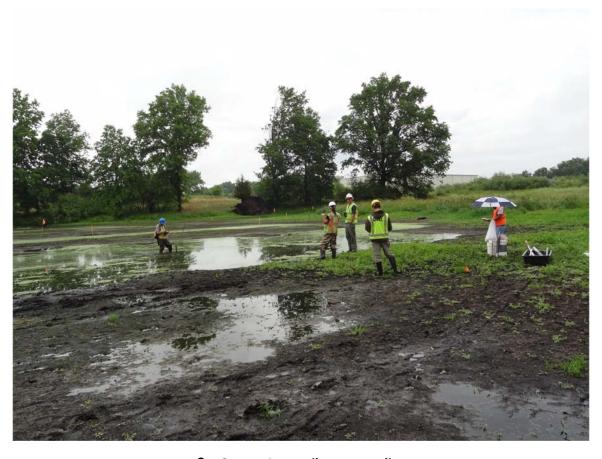
2. Source Area soil core sampling.

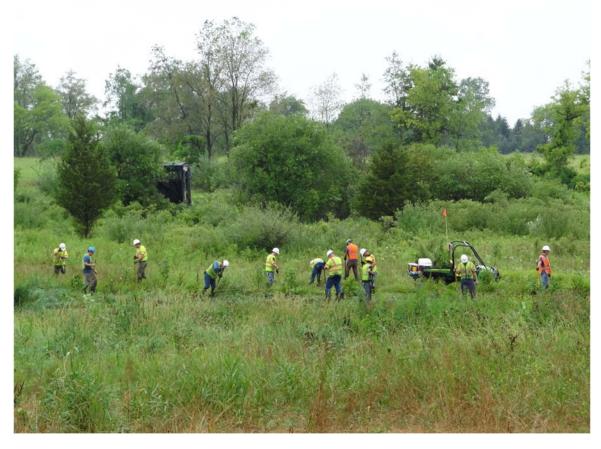
3. Talmadge Creek restoration work

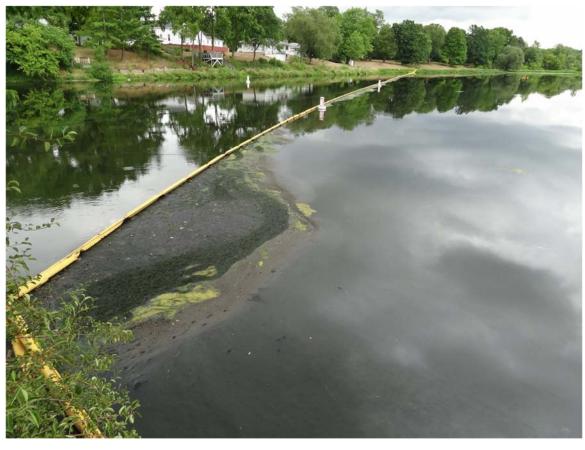
4. Ceresco Dam containment boom.

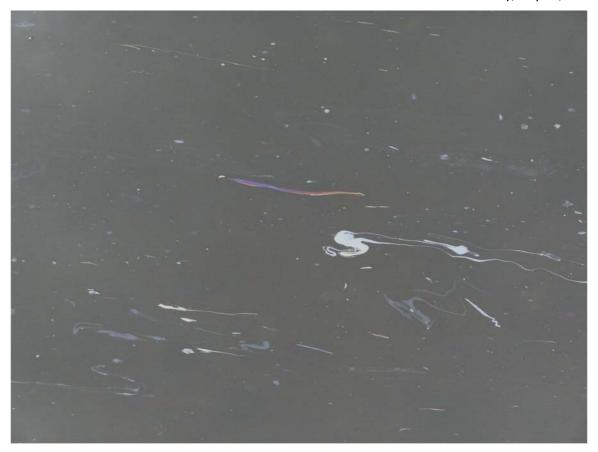
5. Ceresco Dam sheen observed.

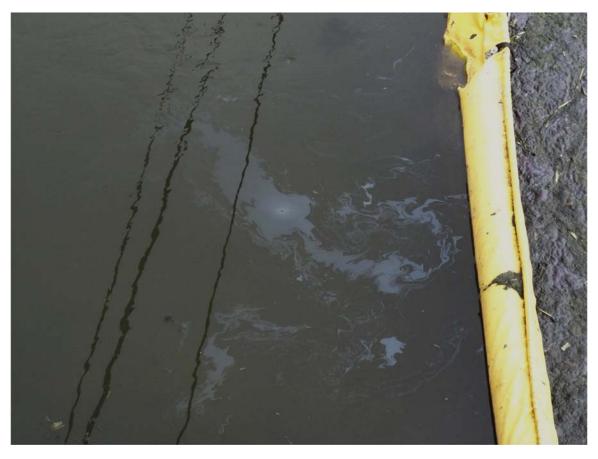
6. Ceresco Dam sheen observed on the downstream side of boom.

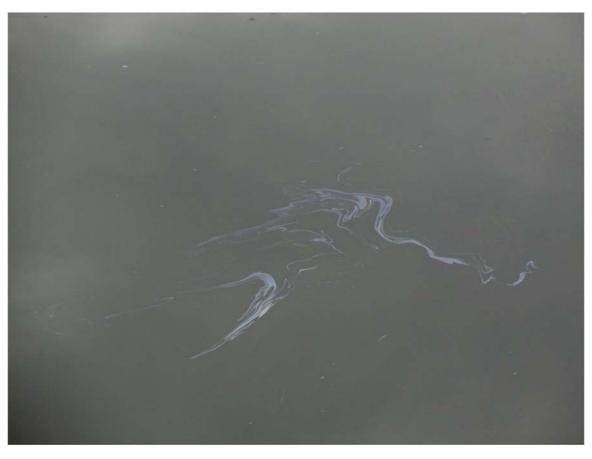
8. MP15.5 South Mill Pond, observed sheen coming out of Mill Pond.

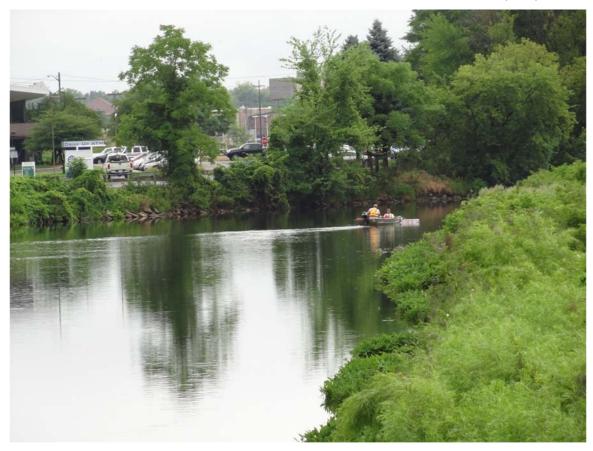
9. North Mill Pond observed sweep boat operating.

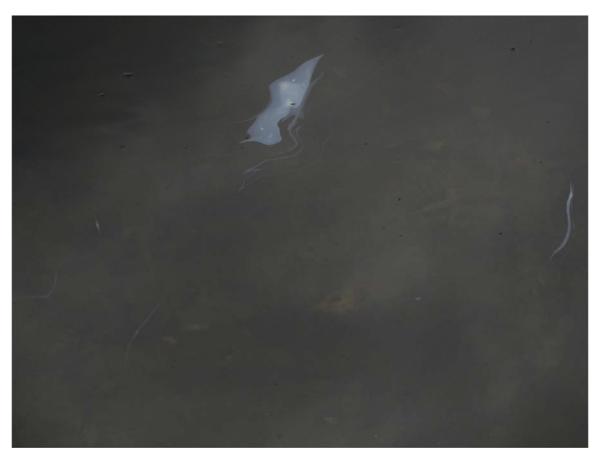
10. C5 Boat launch, observed sheen ribbons continuously floating by. Sweep boat was observed operating in the area.

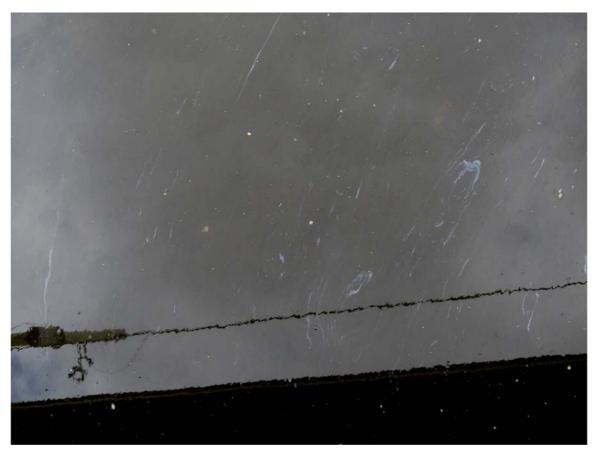
12. MP21.5 sheen observed on the east and west side, operations was notified.

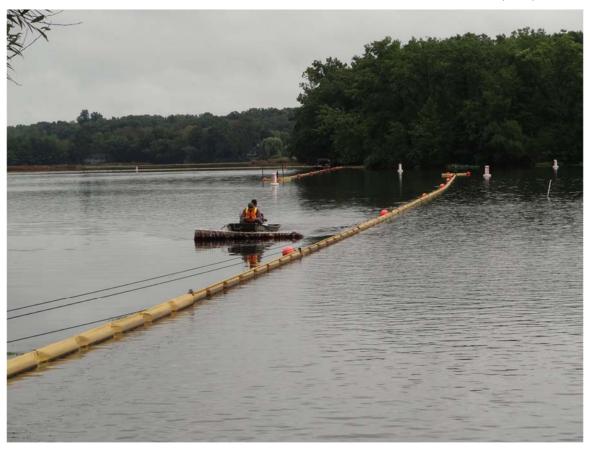
13. Morrow Lake Delta observed a sweep boat operating along Boom E.

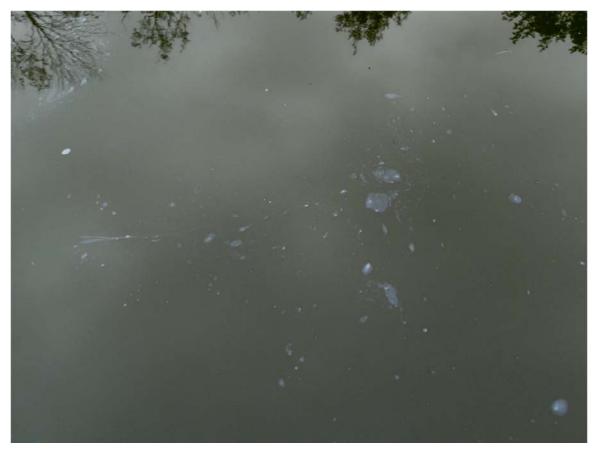
14. Morrow Lake North Cover observed sheen, operations was notified.

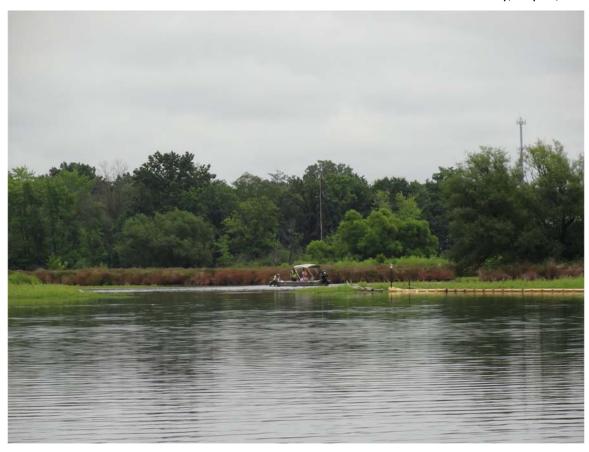
15. Morrow Lake Delta observed poling crew.

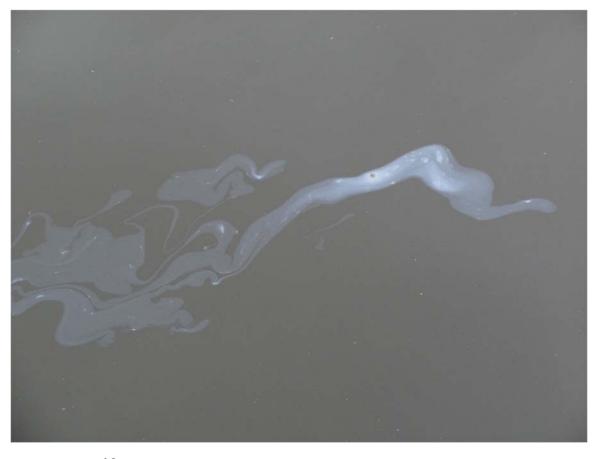
16. Morrow Lake Delta observed sheen collecting behind Boom C.

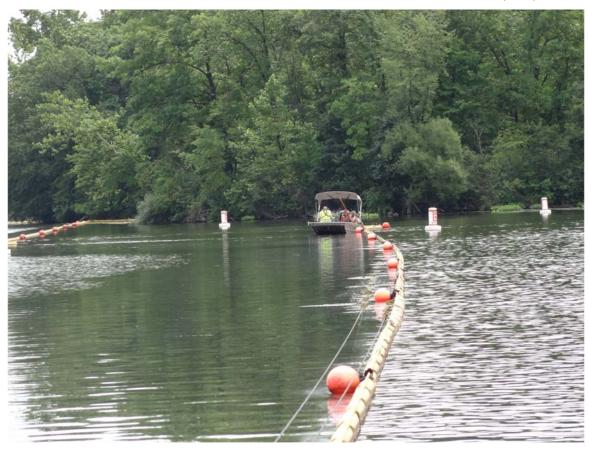
17. Morrow Lake Delta observed crew preforming boom inspection of Boom E with and underwater camera.

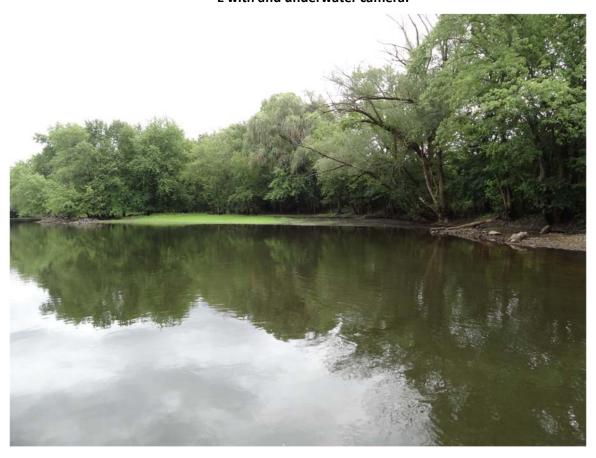
18. MP24.75 LDB sheen observed, operations was notified.

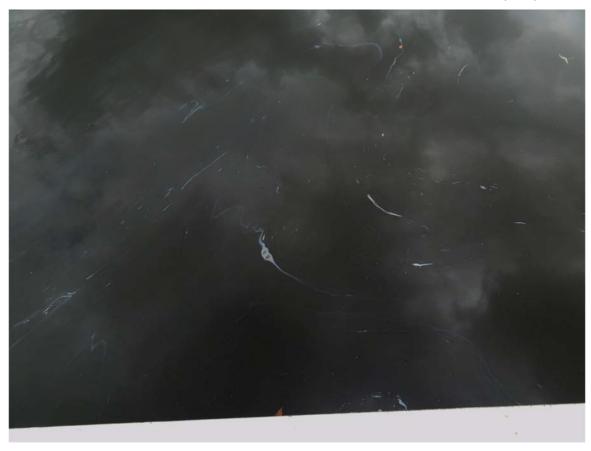
19. MP24.75 LDB sheen observed, operations was notified.

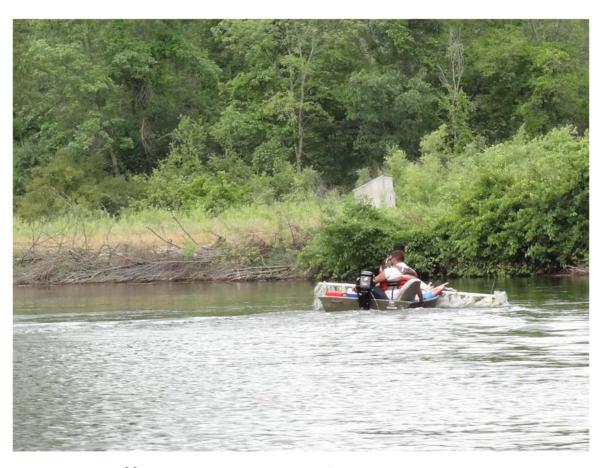
20. Sheen sweep boat mobilizing from MP23.1 to MP24.75.

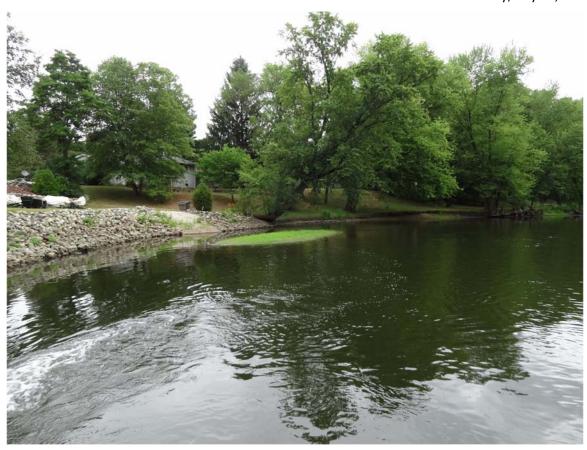
21. MP23.1 RDB sheen observed.

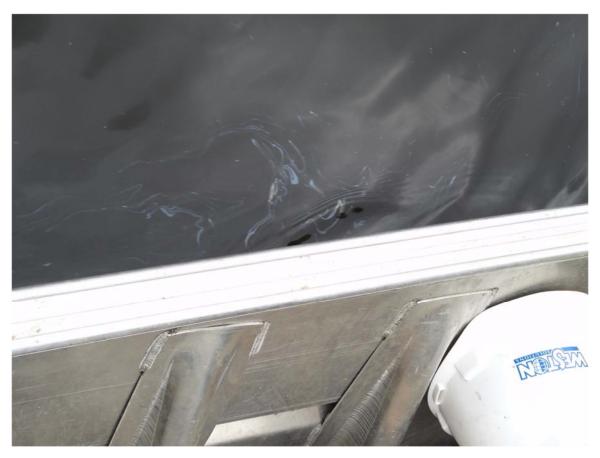
22. MP23.1 RDB sheen observed.

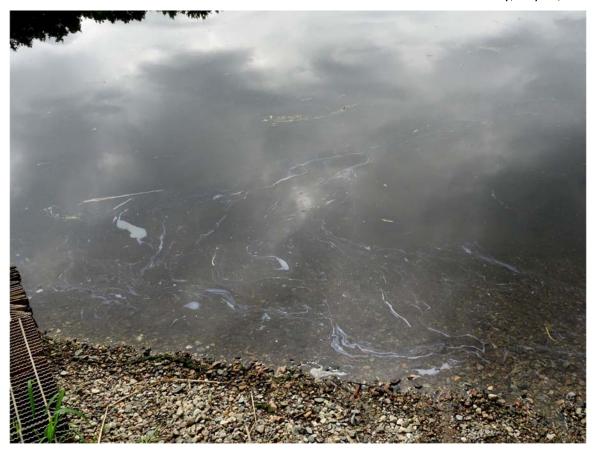
23. C0.4 Boat launch sheen observed.

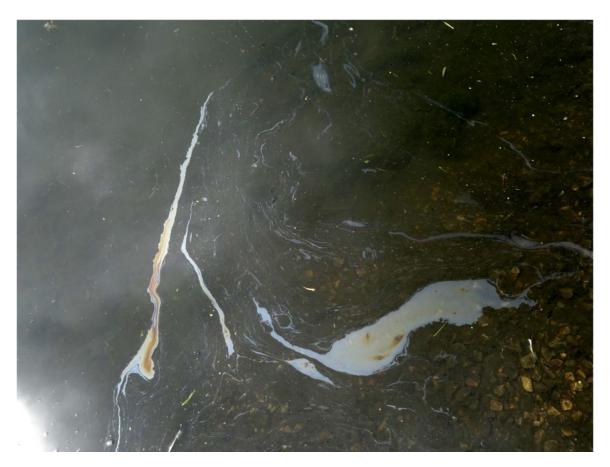
24. CO.4 Boat launch sheen observed.

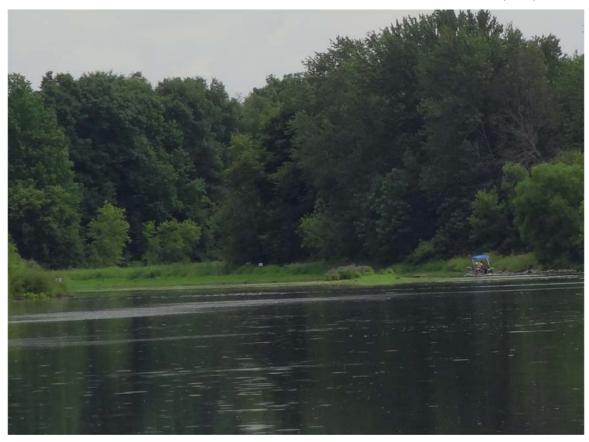
25. Observed sheen sweep boat operating up near MP4.5.

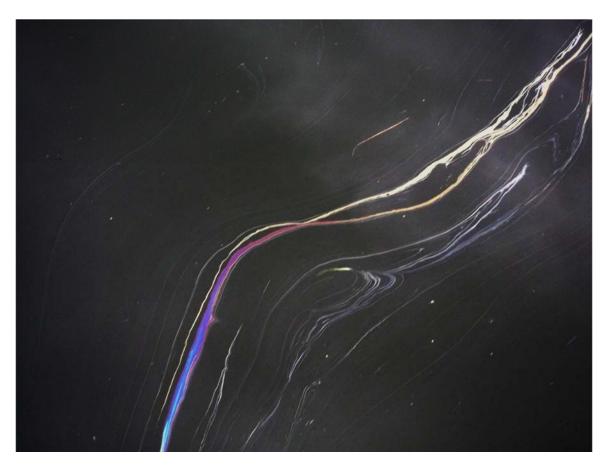
26. MP5.63 LDB Railroad Trestles, sheen observed.

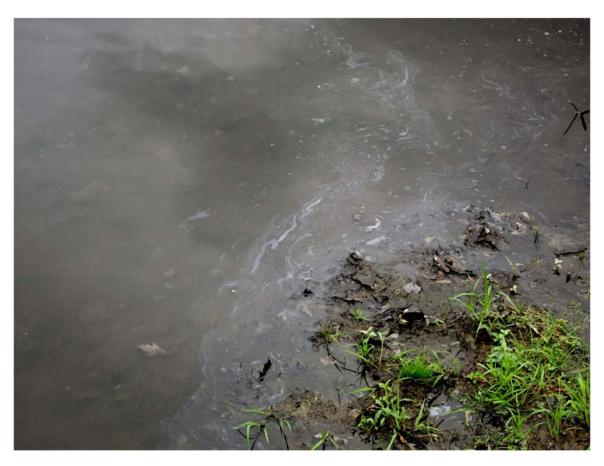
28. MP18.75 LDB gravel bar, boat disturbed sediment and sheen was observed.

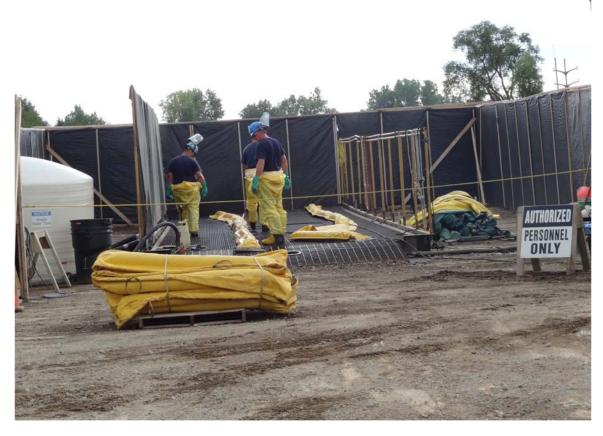
29. Frac-Tank City observed boom being decontaminated.
